BIRMINGHAM HIP RESURFACING
VERSUS CONSERVE PLUS
METAL-ON-METAL
HIP RESURFACING

A SURGEON'S
PERSPECTIVE

DR. KOEN DE SMET

ANCA Medical Centre
Ghent Belgium

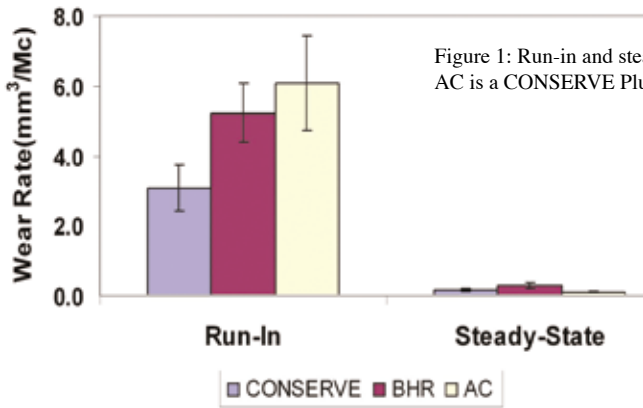
Figure 1: Run-in and steady state wear rates for the 54 mm diameter couples. AC is a CONSERVE Plus left “as cast”.

To demonstrate this fact the company conducted a hip wear simulator experiment comparing 3 types of articulation: heat-treated CONSERVE Plus, “as-cast” CONSERVE Plus and “as cast” BHR [Carroll, 2004] . The results are shown in Figure 1

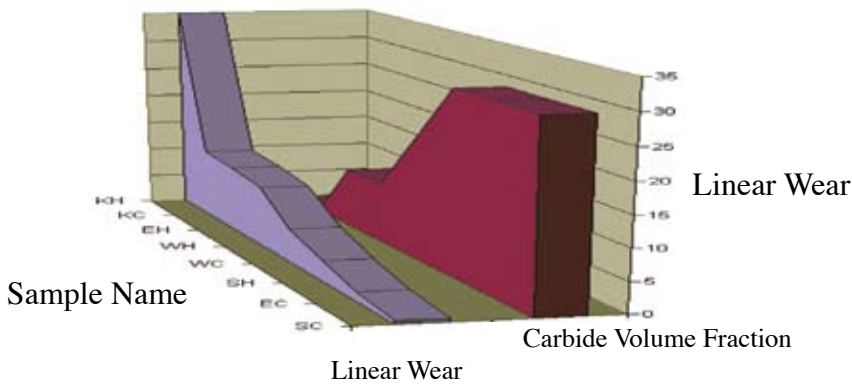
Explant Wear versus Volume Fraction

Figure 2: graph of linear wear vs carbide volume fraction of 1996 McMinn devices (with Courtesy of Tim Band MMT/Smith&Nephew) (KH= Karine head and KC= Karine Cup components)

In 2003 Derek McMinn reported good initial results with the BHR device with the exception of a number of implants produced in 1996 with the double heat treatment method. The manufacturer switched from a single heat treatment to a double heat treatment cycle which resulted in carbide depletion (i.e. melting of carbides into original elements of carbon and metal) which, according to McMinn, resulted in accelerated wear and osteolysis. McMinn's review of four retrievals proposed direct correlation between wear rate and amount of surface carbides. (Fig 2).

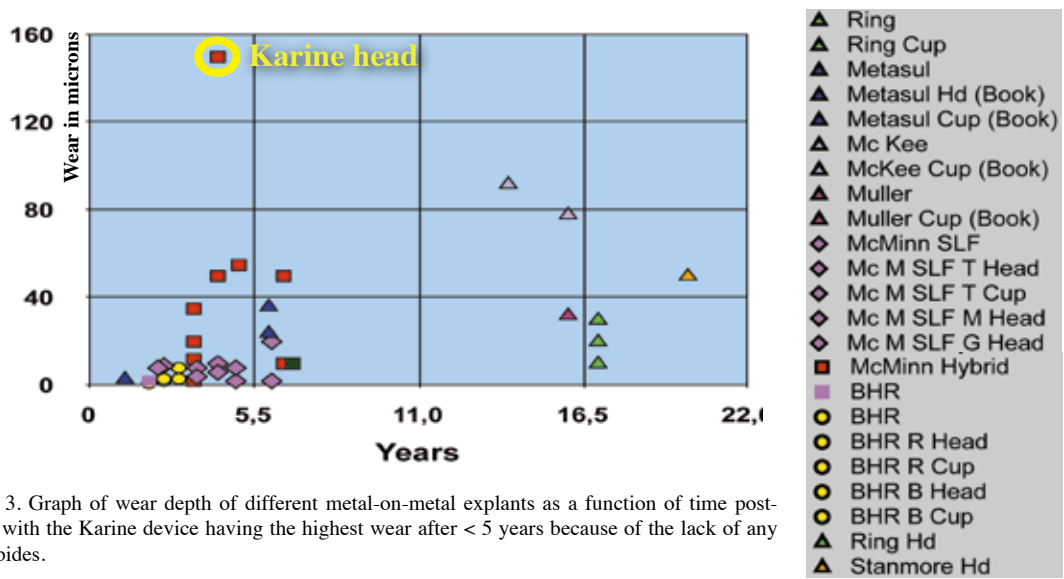
Fig 3. Graph of wear depth of different metal-on-metal explants as a function of time post-op, with the Karine device having the highest wear after < 5 years because of the lack of any carbides.

In Figure 3 below, you see the Karine head component of one of these McMinn devices of 1996, which was revised by myself in 2/2001. CMM measurement showed there was high wear of 150µm on the head side.

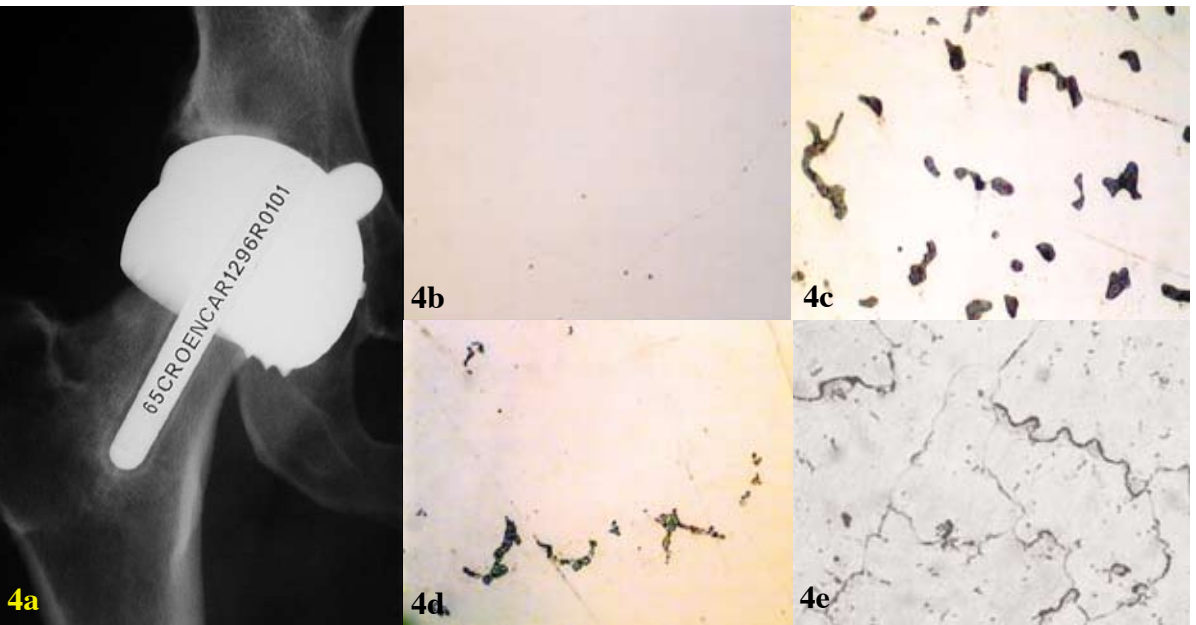
Fig 4 In these figure (4a) we see the 1996 McMinn (Karine) device with osteolysis and the micrograph of the metal showing NO carbide content (4b). In the next figure (4c) you can see how a normal as cast BHR surface contains block carbides. Figure 4d shows the distribution of carbides on a heat treated BHR (fragmented carbide blocks) and figure 4e showing the carbide distribution of a Conserve Plus prosthesis.

Examination and wear measurements of my retrievals are shown in table 2. The Karine device revised in February of 2001 exhibited gray metal-stained tissue, fluid cyst and osteolytic lesions. Wear scar was measured as 150 micron deep and metallurgical analysis did not find any surface carbides (Fig.4).

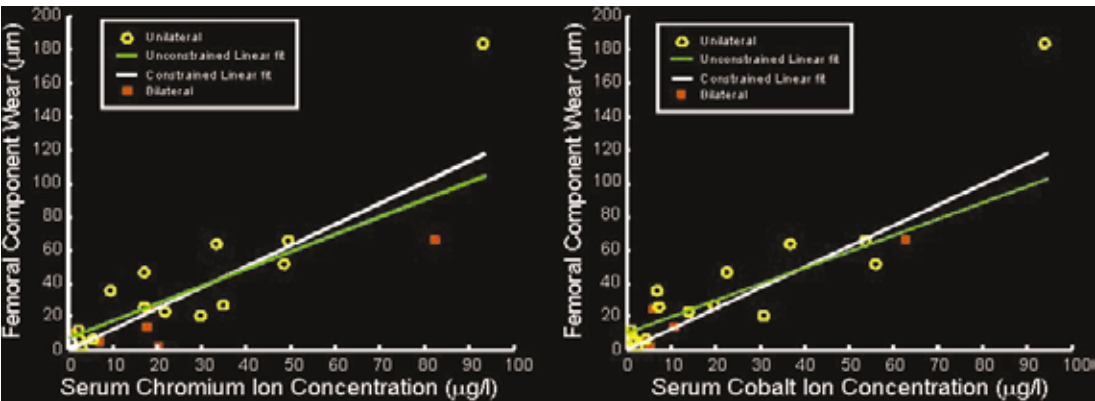
Fig 5. Correlation between femoral component wear depth and serum ion levels.

I have been collecting blood from consenting patients prior to revision surgeries (and at routine follow-up), as well as hip fluid taken from the joint at the time of revision surgery. The levels of metal ions have been measured with inductively-coupled plasma mass spectrophotometry with a resolution of 0.5ppb. Looking at the wear and ion data together, it can be shown that chromium and cobalt levels are correlated with the wear of the prosthesis. [De Smet, 2008] (Fig 5)

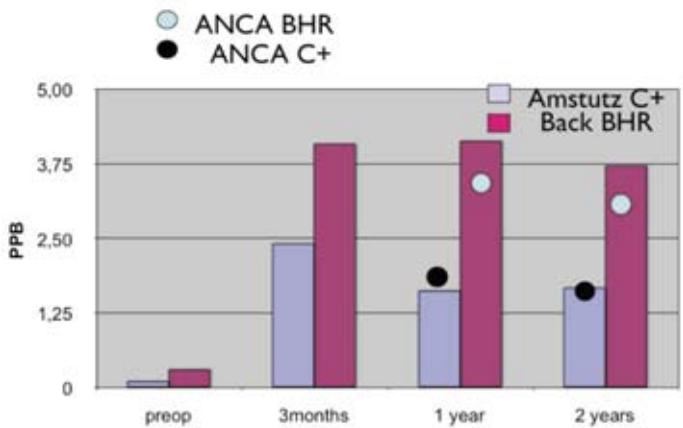
Fig 6. Metal ion levels from the patients in my series compared with those reported with the BHR by Back et. al. and with the CONSERVE Plus reported by Skipor, et. al. All values are reported for blood serum, however it must be noted that the measurements were conducted at different institutions. [Skipor, 2002]

In the data from the Amstutz Conserve Plus series, and the published study of BHR ion values by Back et al, [Back, 2005] the metal ion levels are measured prospectively and longitudinally in a relatively large cohort of hip resurfacing patients where the same surgeon did the implantations, and the same lab did the metal ion testing. My patient ion data is shown against those data (Fig 6) (ANCA series) and this proof is even more evident. These metal ion levels are from normal, well-functioning resurfacing prostheses where the chromium serum level was not higher than 5 µg/l or 5 ppb. Therefore the claim that implants which have been heat treated after casting will have higher wear, (and therefore higher ions) is not supported by this data.

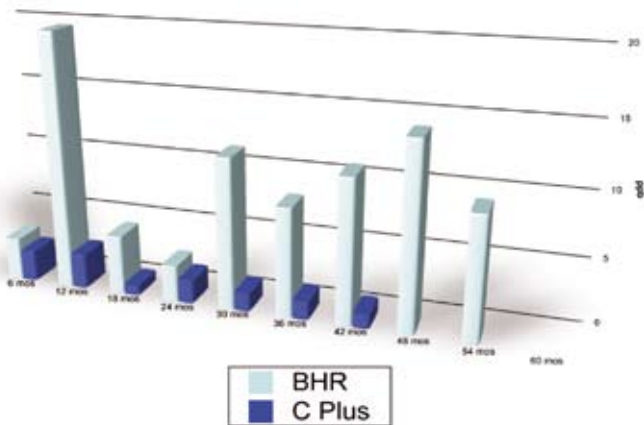
Cobalt in Serum if Cup > 50 degrees

Fig 7. Serum Cobalt levels of BHR and Conserve Plus in steep cups (cup abduction angle > 50°).

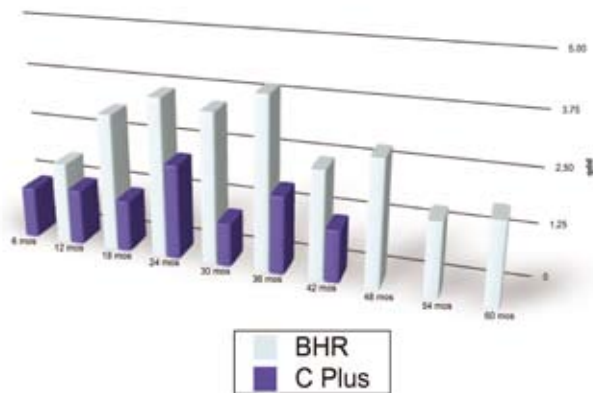
Cobalt in Serum if Cup < 50 degrees

Fig 8. Serum Cobalt levels of BHR and Conserve Plus in well placed prostheses (cup abduction angle < 50°).

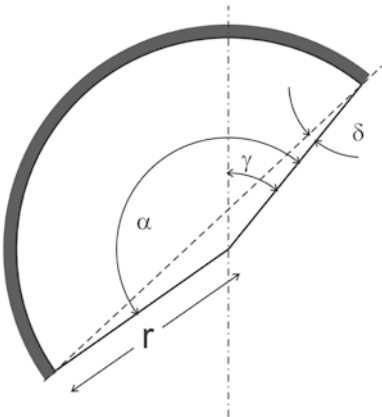
Fig 9. Alpha angle as a function of socket radius.

Smaller coverage means a smaller surface of the socket is available to cover the ball resulting in higher wear of the metal-on-metal joint.

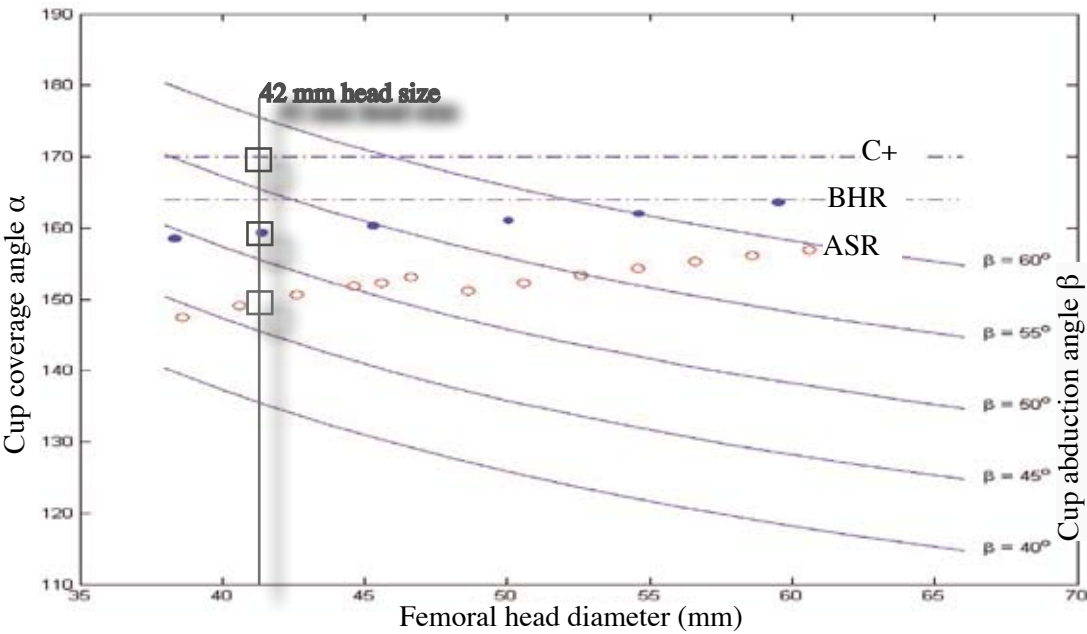
Fig 10. Graph showing the relationship between the head coverage angle alpha, cup abduction angle beta and head diameter. The curved lines are the cut off lines for the coverage angle of the prosthesis needed with a certain abduction angle where the surgeon has placed the cup. For example, a 42 mm ASR device is at risk for edge loading starting 45 degrees of abduction, the BHR device is at risk above an angle of 52 degrees, the Conserve can be put in a 57 degrees steep position before the edge loading and wear starts. (Gray line and rectangles) (R.De Haan 2008, page 24)

The importance of these three aspects (cup abduction angle β , head diameter and head coverage angle α) and their influence on wear of the prosthesis is demonstrated in figure 10. One can see from this graph that a Conserve Plus device with 170 degree head coverage angle α can withstand steeper cup placement before encountering an edge-loading condition than the BHR device with a **maximum** of 164 degree head coverage angle, this difference being more pronounced with smaller diameter components (**blue dots**). This is also the case for the ASR device (Articular Surface Replacement)(DePuy J&J) which has even smaller head coverage angle than that of the BHR (**black circles**).

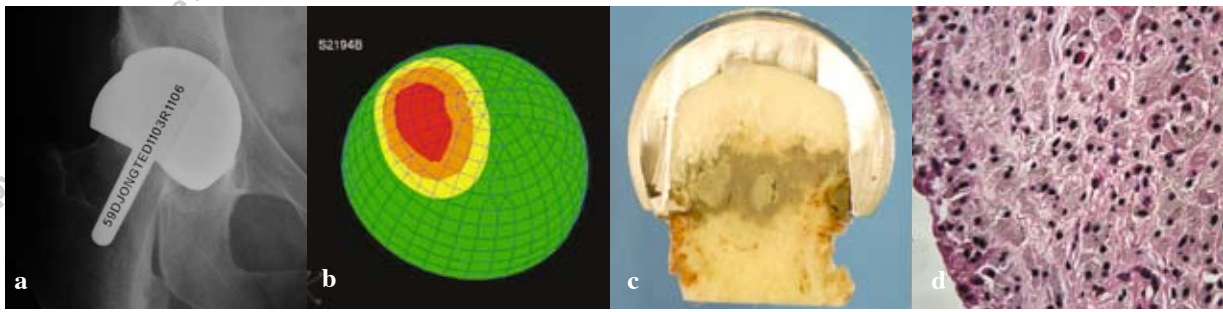
Fig 11. (a) x-ray of a size 46 mm diameter BHR with a steep cup (61° abduction angle), revised for pain from impingement and swelling as a result of the high wear from edge loading (b) The CMM wear measurements showed 66 micron maximum femoral wear. (c) The sectioned femoral head revealed wear-induced osteolysis (d) Histology confirmed the metallosis findings with massive infiltration of macrophages containing wear particles. The serum metal ion levels were 55.0 ppb Chromium, 73.9 ppb Cobalt.

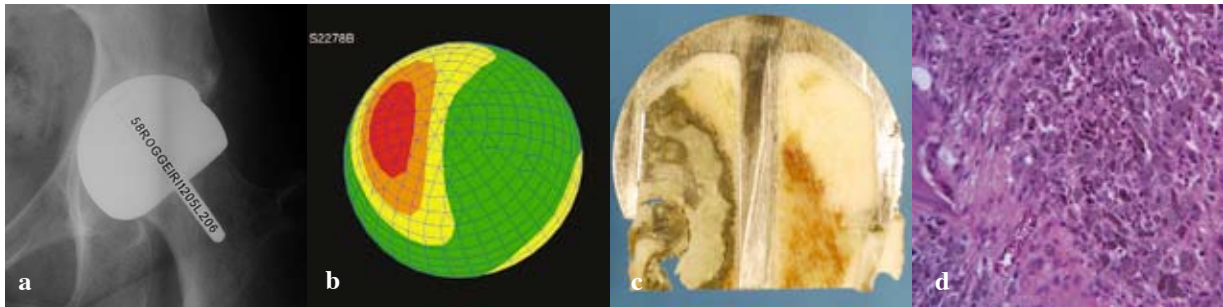
Fig 12. (a) x-ray of a size 47 mm diameter ASR with a steep cup (59° abduction angle), revised for pain as a result of high wear from edge loading (b) The CMM wear measurements showed maximum femoral wear depth of 81 micron. The maximum acetabular wear depth was 26 microns. The diametral clearance was 132 microns. (c)(d) The femoral head is viable and vascular, but is being resorbed by invasive metal-filled macrophages The serum metal ion levels were 56.9 ppb Chromium, 72.4 ppb Cobalt. Revision was performed after 22 months.

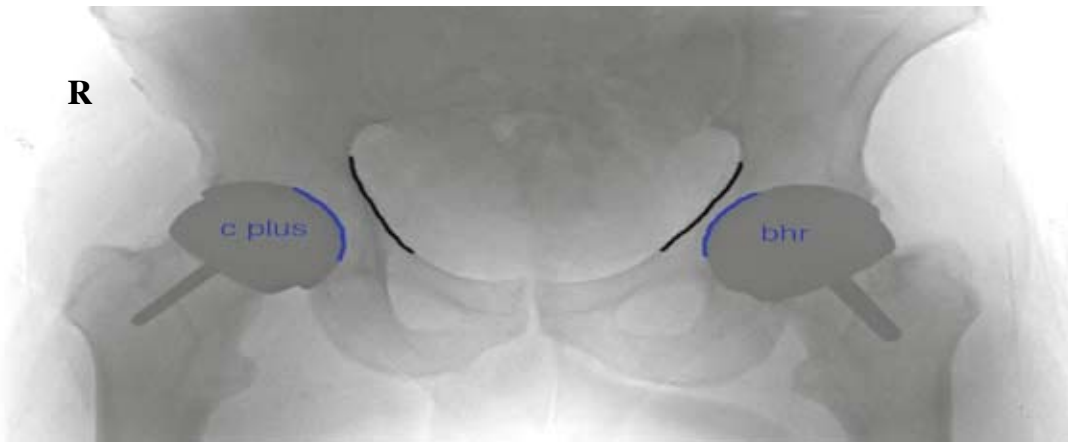
Fig 13. Pelvic x-ray where the left side is a Birmingham Hip Resurfacing and the right is a Conserve Plus. The hemispherical (180°) socket and 4 mm size increments of the Birmingham Hip Resurfacing design result in more bone loss in the pelvis compared with the Conserve Plus which has a lower profile (174°) and is available in 2 mm increments.

In the USA, the FDA approved BHR is available only in 4 mm size increments; this can lead to an even greater loss of acetabular bone stock (Fig 13). In Europe where the Birmingham is available with the 2 mm increments, this is less of a problem and subsequently the problem of choosing the wrong size of component has also been reduced. The Conserve Plus design has always had the 2 mm increments which allows the surgeon a broader choice.

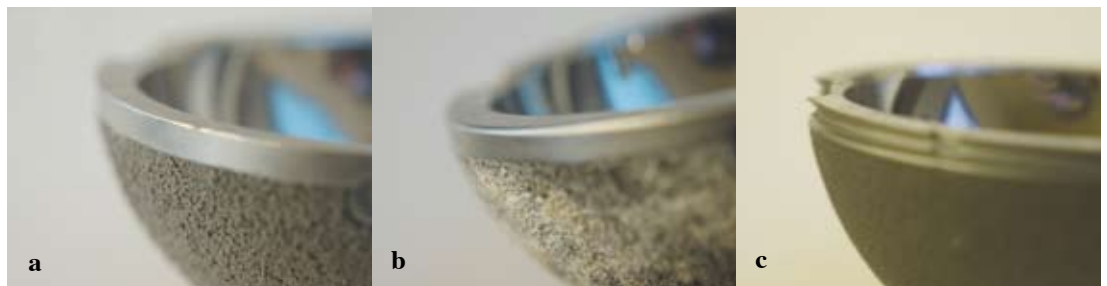
Fig 14 (a,b). Changed edge of cup from sharp to rounded edge design in Conserve Plus. (c) Sharp “knife blade edges” of Durom design resurfacing cup (Zimmer).

Unlike some other socket designs including the BHR, the edge of the Conserve Plus socket is NOT sharp. The rounded edge of the cup better protects the patient against groin pain caused by “iliopsoasitis”. (local conflict of soft tissue or iliopsoas tendon with the edge of the cup)

This technique dependent problem will be exacerbated when the cup edges are not rounded. It seems intuitive that the sharper the edges are, the more problems are encountered. Reports of painful Durom resurfacings may be related in part to the 3 sharp edges of this socket design (The New York Times newspaper, page 23).

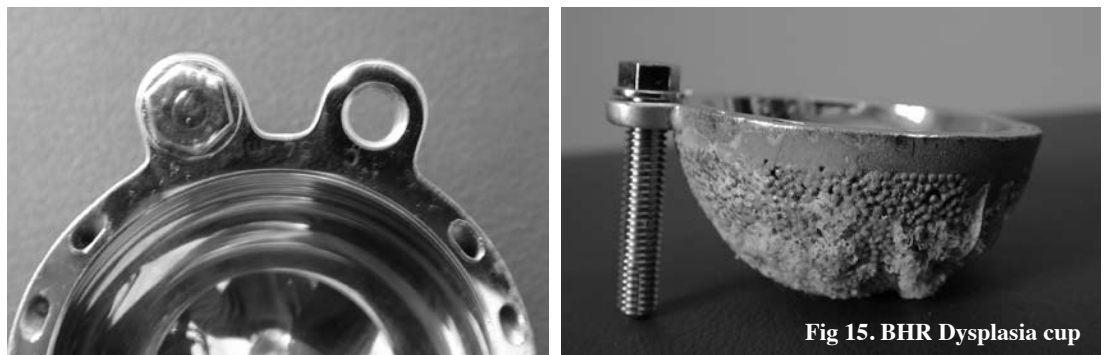
The BHR dysplasia cup has 2 so-called “Mickey Mouse” ears (screw holes) that are threaded and are in line (in the same plane) with the cup, as well in the same plane, with no angle to the neutral plane for anteversion. (fig 15)

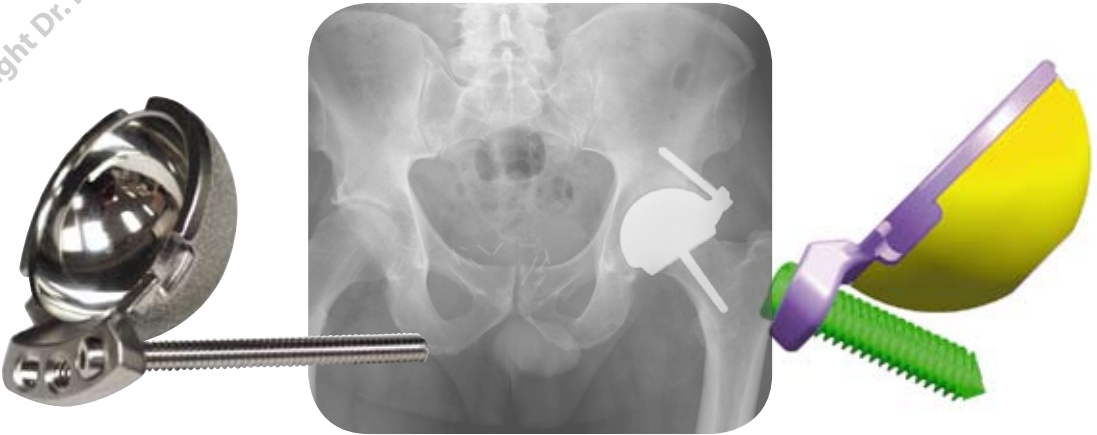
Fig 16. Quadrafix Conserve Plus cup. Implant with flange and one screw, x-ray of an implant and a CAD picture showing the 20 degree angle of the screws. Quadrafix cups are available in 2 mm increments.

The Conserve Plus dysplasia cup design (QUADRAFIX) has a flange with 3 holes (1 cup for both sides) where there is a flange with a small distance away from the edge of the cup (Fig 16). As such it can also be used in non-dysplasia cases, such as in revision of resurfacing or non-dysplastic cases where enhanced fixation is needed. The direction of the screws is angled 20 degrees toward the bone of the acetabulum in abduction, and 20 degrees of retroversion to neutralize the anteversion of the cup. The second screw is neutral to the anteversion angle of the cup.

These improved screw angles direct the screws into the bone with a well positioned cup. In the BHR dysplasia cup the screws tend to go out of the bone or do not reach the bone.

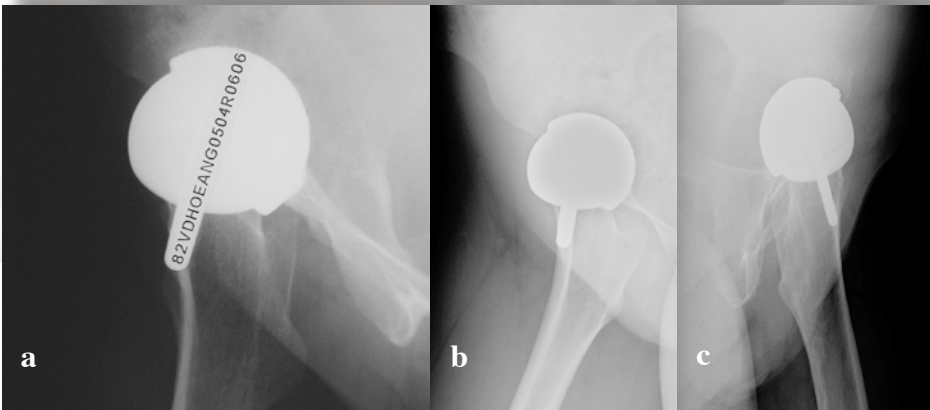
Fig 17. Protrusion of stem in BHR cases (a,b). Thinner stem of Cplus just touching the cortex. (c)

The stem of the Conserve is much thinner than the BHR stem and it changes proportionally with component size, i.e. becoming shorter and having a smaller diameter as the femoral component gets smaller. This allows more correction in the placement of the femoral component and fewer problems of “protrusion” of the stem, “stress shielding”, or femoral fracture risk, because the stem is touching or protruding through the cortex of the femoral neck.

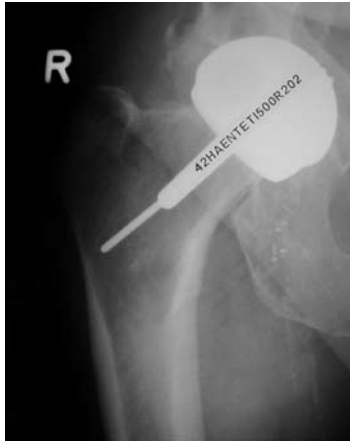
Fig 18. Follow-up x-ray at 2 years with guiding pin for femoral placement still in the femur.

The BHR femoral surgery starts with a “pin introduction” in the lateral cortex but the pin can stay in the femur and I have 2 cases where that happened. (Fig 18) With a pinless guide this would not have happened.

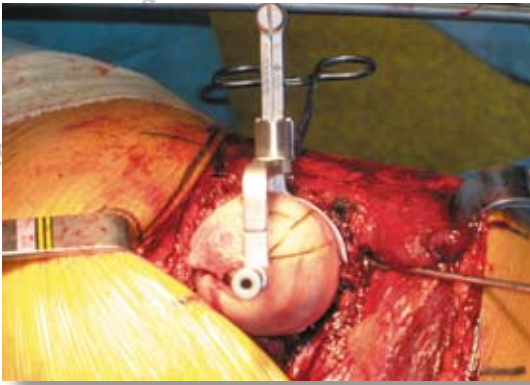
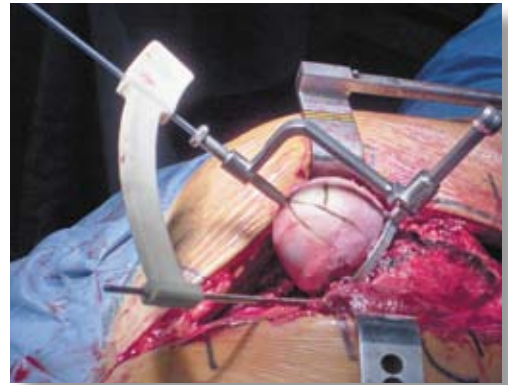
Fig 19. Lollipop device and mounted lollipop/goniometer device for K-wire introduction and exact pin placement for the femoral procedure of Conserve Plus.

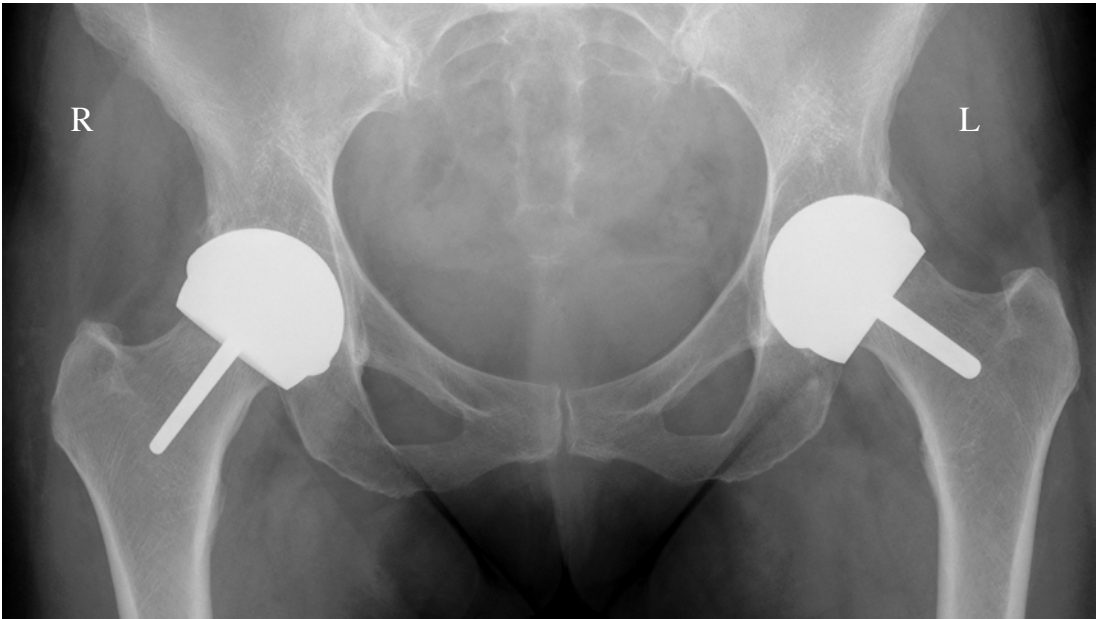
Fig 20. Pelvis x-ray showing a Conserve Plus on the right hip, a BHR implant at the left.

An MIS cup impactor and a lateral approach goniometer are currently in production with Conserve Plus. In figure 20 you can see that the right hip resurfaced with a Conserve Plus and has correct (140 degree) varus/valgus angle, and correct mediolateral placement, i.e. with the same distance medially and laterally in correspondence with the femoral neck. On the left side you can see a Birmingham Hip Resurfacing with a less correct, slightly varus angle and too much shift medially i.e. with more risk for lateral femoral neck notching. This is only one example of the less than ideal positioning of BHR in comparison with Conserve Plus which I attribute to the instrumentation differences. Note again in this example the less conservative treatment of the pelvic bone on the left side Birmingham Hip Resurfacing (i.e. where larger size increments require greater amounts of bone to be removed)

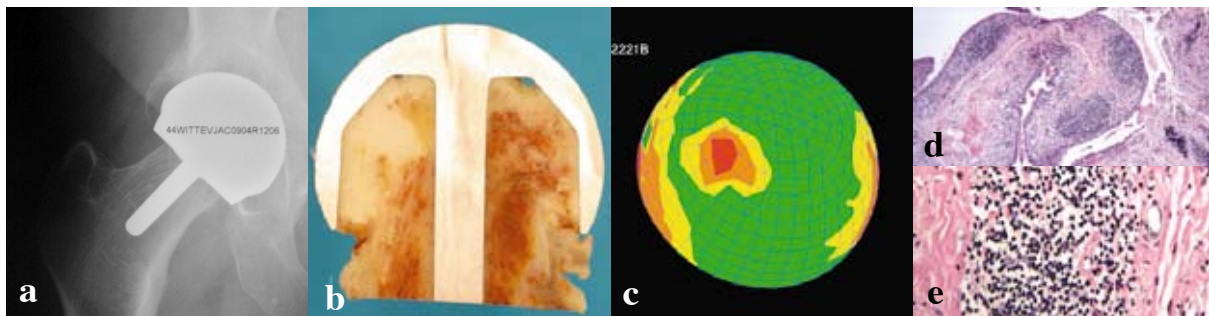
Fig 21 . (a) X-ray of a right BHR in 63 year old female revised for suspected metal sensitivity, osteolysis in the pelvis and femoral neck narrowing (38 months follow-up), (b) mid-section of the retrieved femoral head showing neck narrowing in the absence of wear. (c) CMM measurement of femoral component with maximum femoral wear depth of only $4.7\mu\text{m}$. (d)(e) Villous synovium with extensive lymphocytic infiltration and relatively few macrophages. Taken together, the analyses indicate that this is a case of metal sensitivity. Contrast to the case in figure 10, revised for acetabular malposition and wear.

Such wear related problems have yet to be seen in the Conserve Plus group; those failures included 1 malpositioned acetabular component (68 degrees of abduction, this socket was revised at 3 months and the resurfacing was preserved), and 2 femoral loosening at 8 and 9 months as the result of over-penetration of cement. Revision for suspected metal allergy was required in 3 patients (4 hips, all BHRs); the diagnosis was confirmed by histology and normal, low wear or ion measurements. (Fig21)

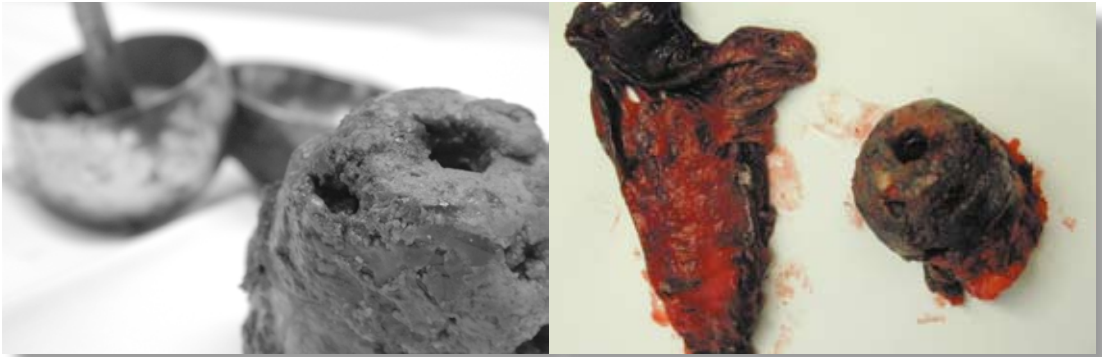
Fig 22. These pictures show the consequences of unrecognized high wear and metallosis: this BHR was implanted with a steep cup and excessive anteversion leading to a total wear depth of more than 200 microns, enlarged black fluid-filled bursa formation, osteolysis of the bone and finally loosening of the femoral component. With routine metal ion measurements and meticulous follow up, this case would have been recognized as having wear, and would have been revised earlier than 56 months.

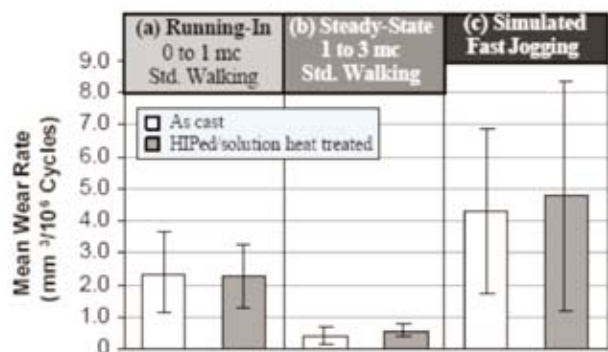
Figure 23: Mean volumetric wear rates of “as cast” and double-heat treated 40mm diameter couples, Cormet 2000.

This work was substantiated by several other sources
(Box 2, Figure 23, Box 3)
page 23

Box 2. “Changes in alloy micro-structure (due to double heat-treat cycle of HIPping and Solution Annealing) do not appear to influence the wear behavior of high-carbon cast MOM articulations” Bowsheer, et. al.
